PRE-PURCHASE STANDARD BUILDING REPORT

Report number: 1906172

Inspection date: 19 Jun 2017

Property address: Budgewoi

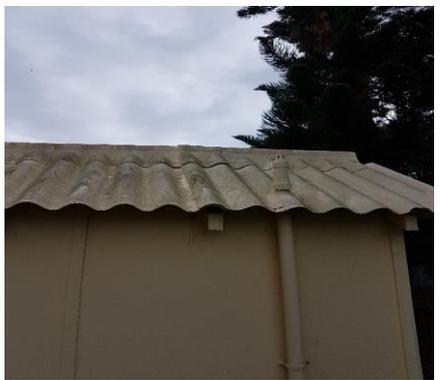
Fibro cement sheeting known as "super six" on the out house toilet and side fence contains asbestos, Proper care should be taken if removal is needed.

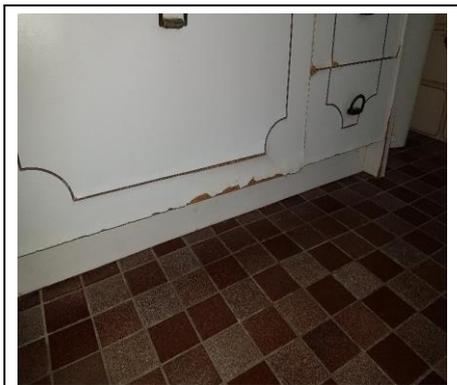
Vanity is in poor condition and needs to be replaced

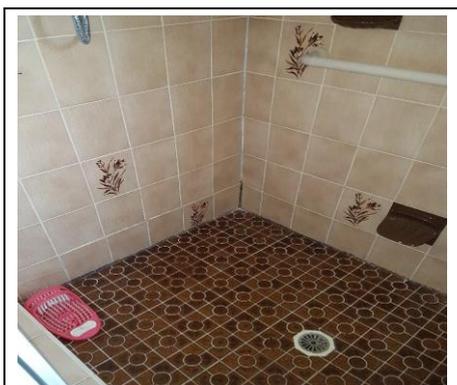
Subfloor, Evidence of old water leakage was noted during our sub floor inspection. The leakage appears to be coming from the shower recess and may not be obvious until the shower is used frequently. There has been no significant structural damage; however, the problem should be monitored.

Cracked and or drummy tiles to the shower walls were noted, maintenance and repair to rectify is recommended.

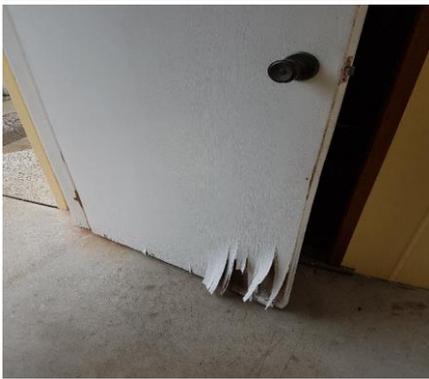
Delaminating Doors, The bottom of the door is delaminating and will eventually require replacement.

Replace external doors, We would recommend replacing the laundry door with an exterior graded door

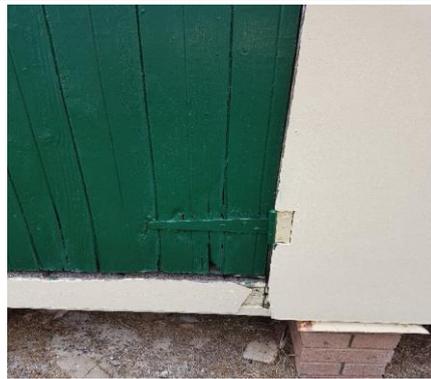
Replace external garage doors, We would recommend replacing the laundry door with an exterior graded door

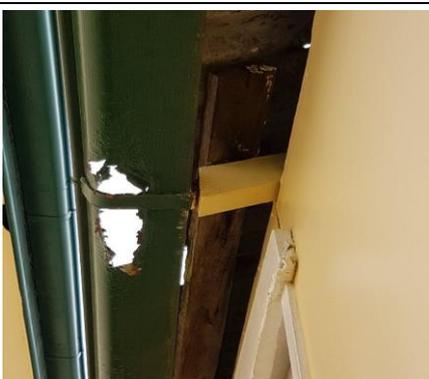
There are rust holes, rust scale to the garage gutters - consider replacing the garage gutters

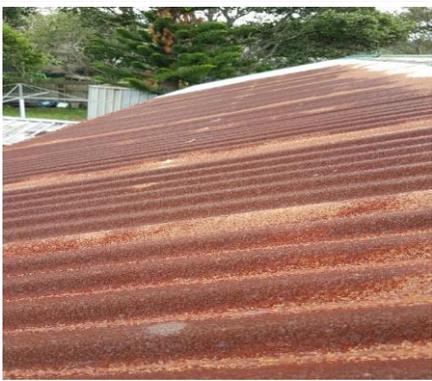
Roof fixings on the garage are coming loose and these loosening sections require repair.

The roof surface on the garage is deteriorating and consideration should be given to replacing the roof sheeting – see a roofing contractor

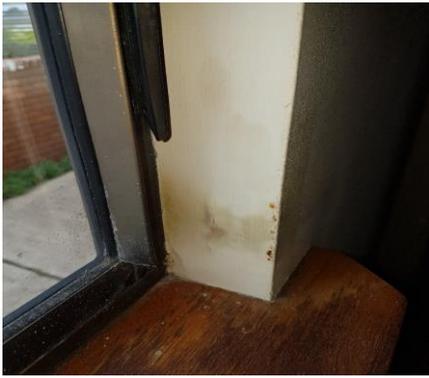
Water damage, Sections of window sills are water damaged and may indicate previous or current window leaks on the eastern side. Recommend contact a builder to repair if further leaking occurs.

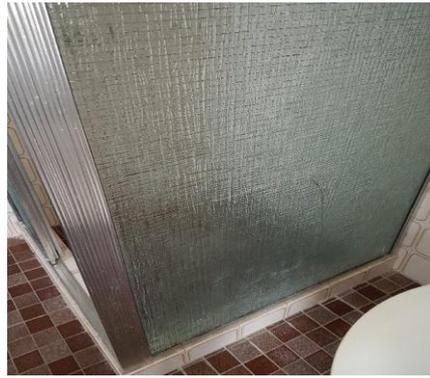
Cracked Glass, The shower screen glass is cracked, maintenance and repair to rectify is required.

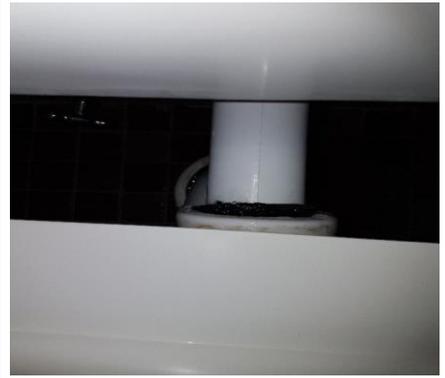
The flush pipe rubber on the granny flat is leaking. consult a plumber for repairs

The toilet pan in the granny flat is loose on the floor and requires repair – Consult a plumber for further advice

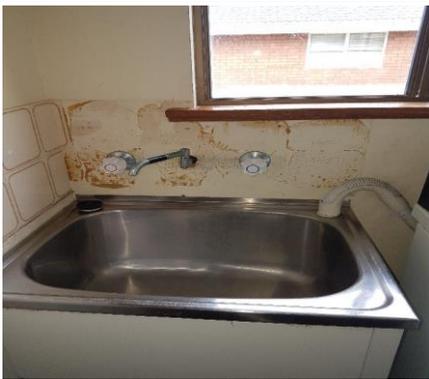
There are no splash back tiles to the laundry tub

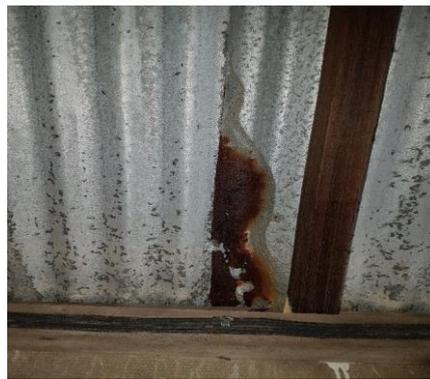
Rust and Corrosion was noted on the underside of the garage roof sheets. These areas need to be de-rusted and repainted with a cold galvanising paint product to prevent further damage or replaced.

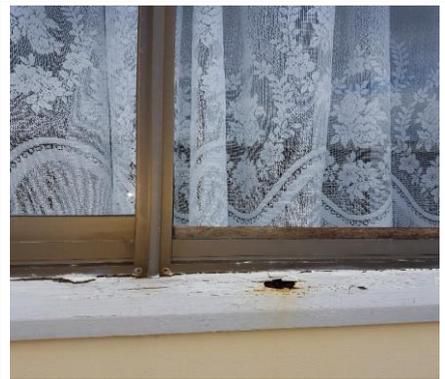
Wood decay (also known as dry rot) damage was sighted on the window trim timbers. Wood decay is conducive to termite activity; therefore we would recommend replacing the damaged timbers at the earliest convenience.

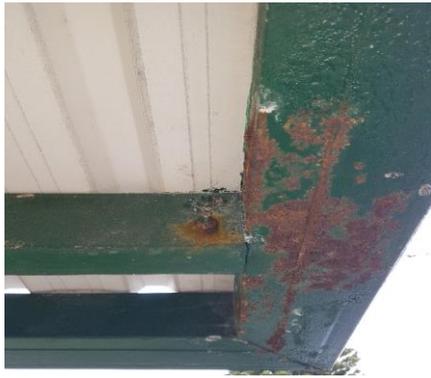
Rust and Corrosion was noted on the underside of the front verandah. These areas need to be de-rusted and repainted with a cold galvanising paint product to prevent further damage

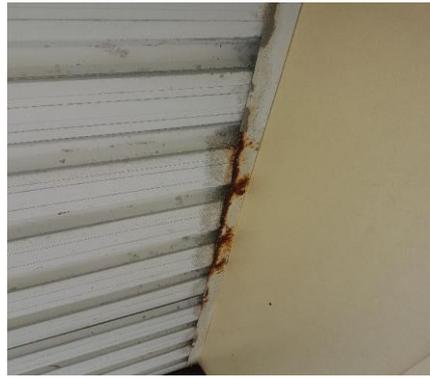
Rust and Corrosion was noted on the underside of the front verandah. These areas need to be de-rusted and repainted with a cold galvanising paint product to prevent further damage

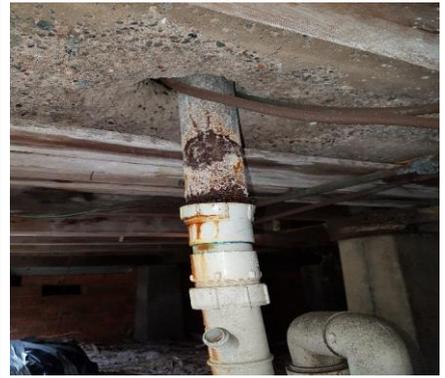
The bath drain pipe is leaking under the subfloor. Recommend a plumber repair.

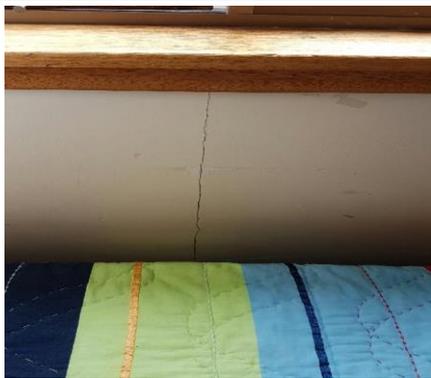
There is some minor cracking along the cornice line and walls in some rooms

Major plaster & paint defects to the internal linings are noted, patching & painting would greatly improve the overall appearance.
