# Pro Property Reports

## STANDARD Dilapidation / Condition REPORT

Report number: 1605173

Property address: Details Withheld  
Speers Point

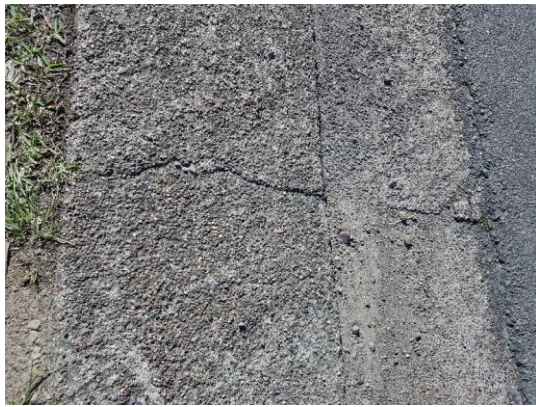
HN 348 Cracked Kerb and Gutter

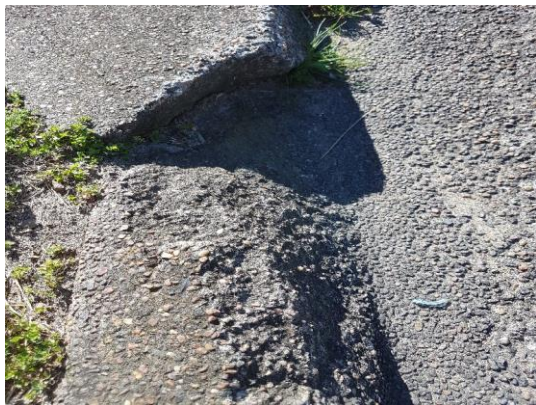
HN 348 Cracked Kerb and Gutter

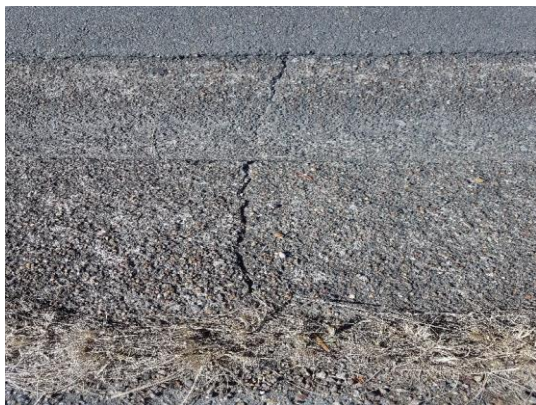
Cracked Driveway about the middle of HN346

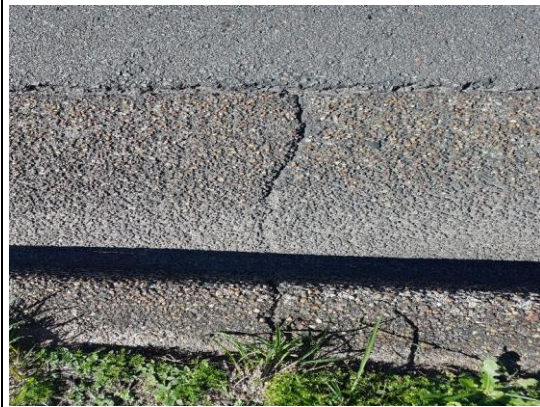
HN 346 Cracked Kerb and Gutter

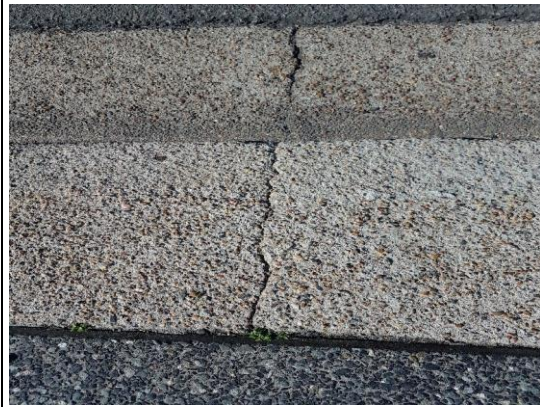
Crack in driveway about middle HN 344.

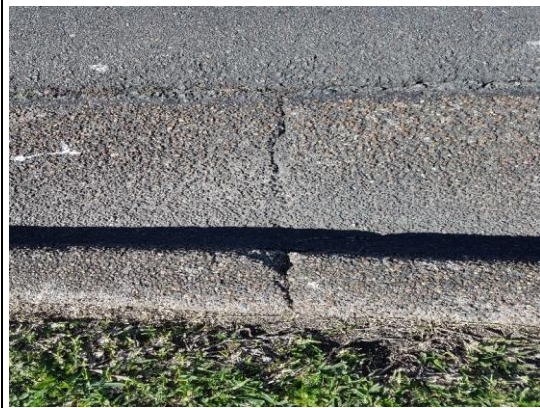
HN 344 Cracked Kerb and Gutter

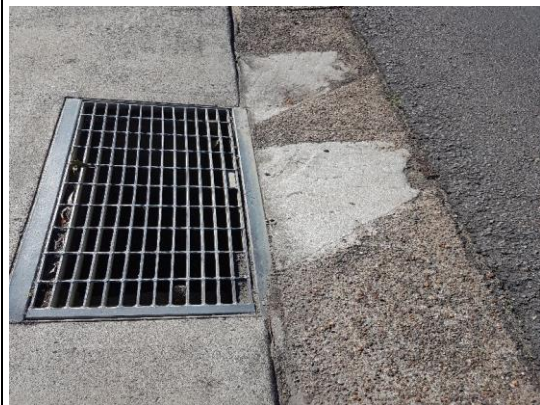
HN 344, repairs to gutter and driveway noted

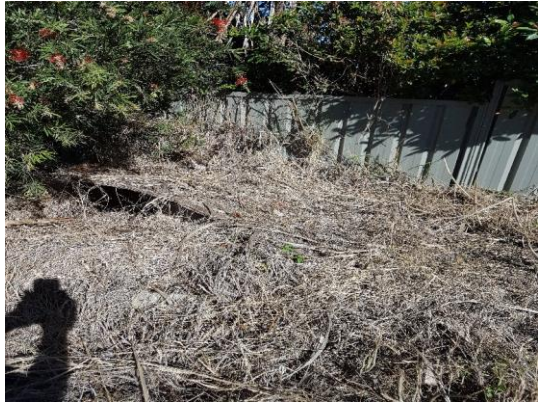
Debris near front of HN346

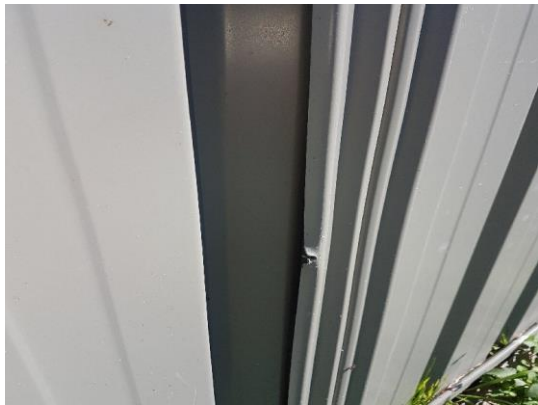
HN344 & 346 rear corner approx. 2m from the corner on the dividing fence damage to sheet

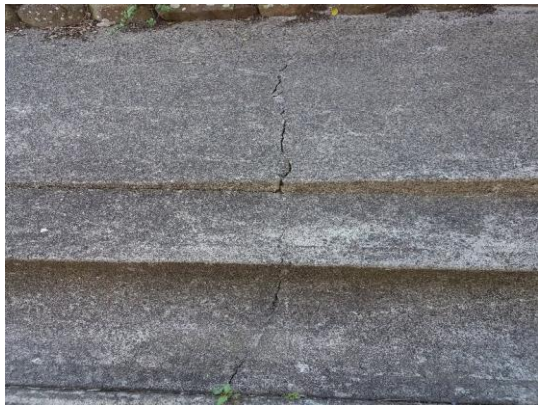
Cracked path HN 348 near front carport / pergola

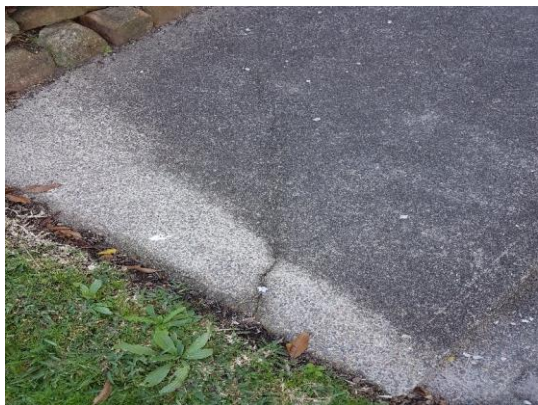
Cracked path HN 348 front

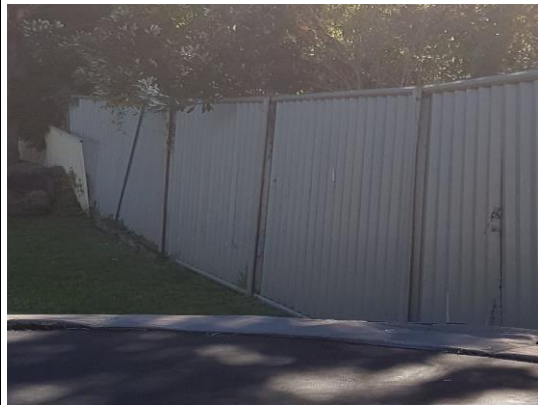
Fence of the rear land North of HN 344 out of alignment

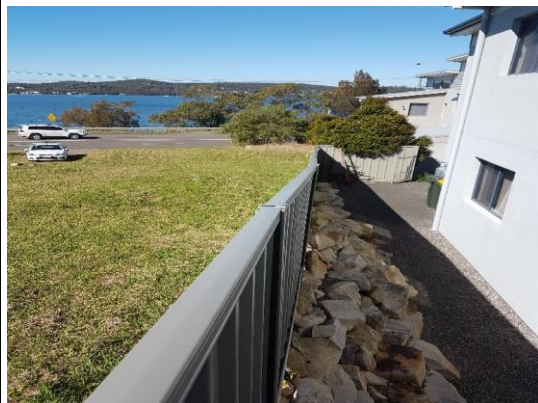
Unit 2 HN 344 & 346 div fence out of alignment

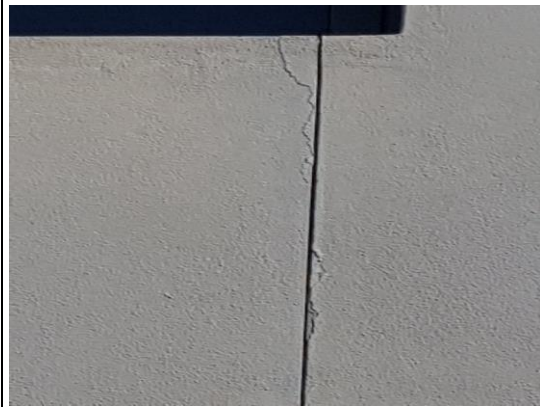
Cracking of render finish on UNIT 1 HN 344

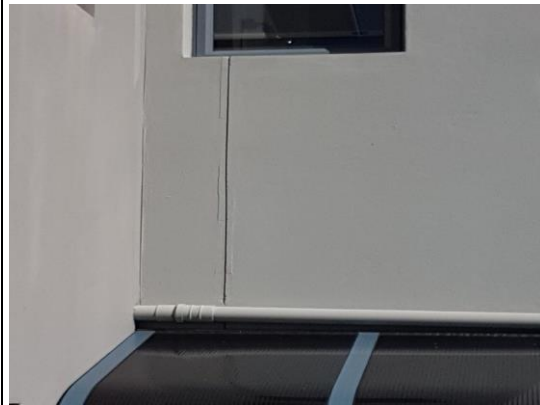
Cracking of render finish on UNIT 1 HN 344

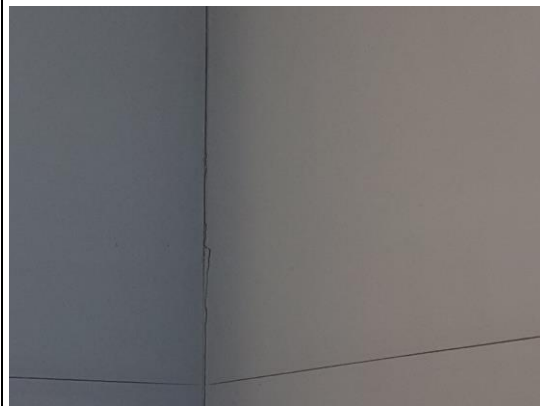
Cracking of render finish on UNIT 2 HN 344

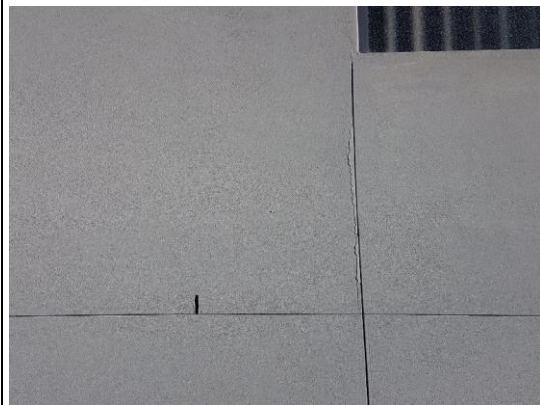
Cracking of render finish on UNIT 2 HN 344

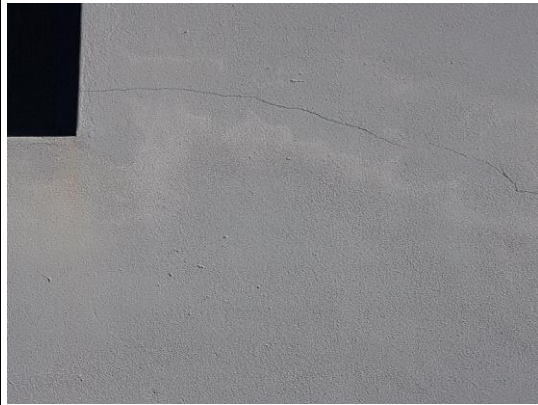
Cracking of render finish on UNIT 2 HN 344

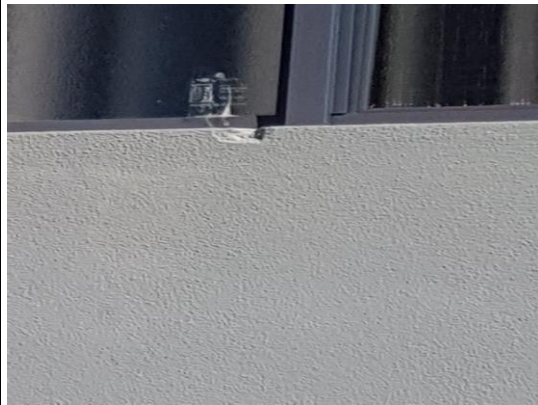
Cracking of render finish on UNIT 2 HN 344

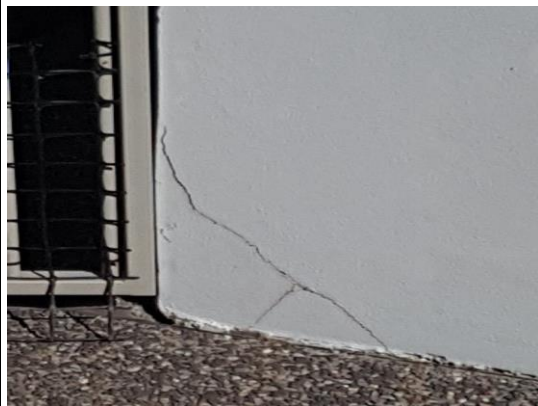
Cracking of render finish on UNIT 2 HN 344

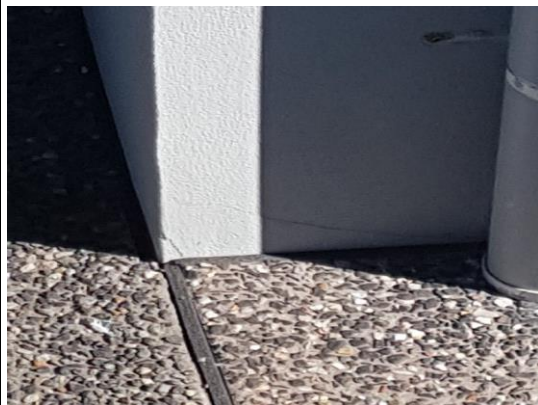
Cracking of render finish on UNIT 2 HN 344

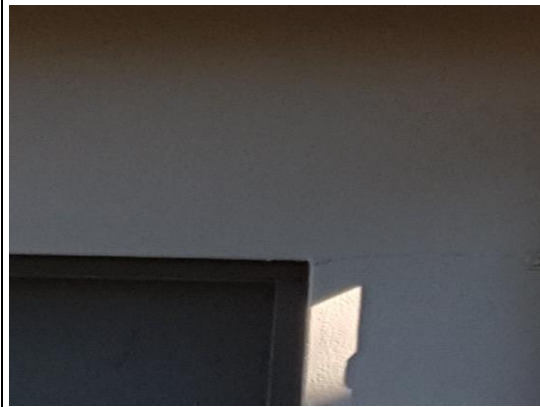
Cracking of render finish on UNIT 1 HN 344

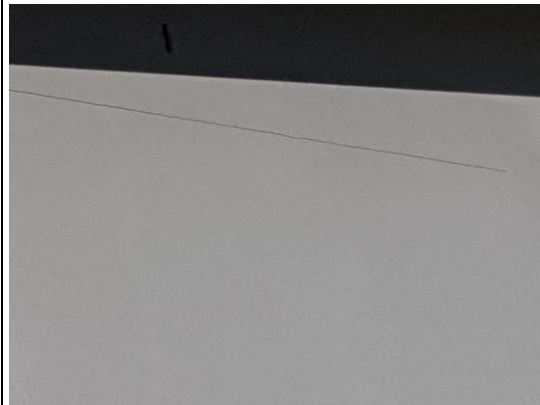
Cracking of render finish on UNIT 1 HN 344

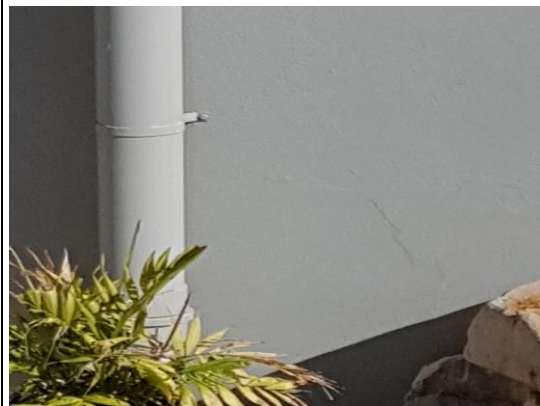
Cracking of render finish on UNIT 1 HN 344

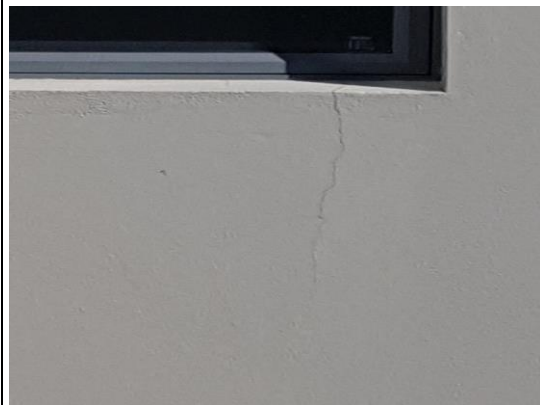
Cracking of render finish on UNIT 1 HN 344
