## VISUAL DILAPIDATION / CONDITION REPORT

Report number: 1506173

Inspection date: 15 Jun 2017

Property address: (removed)  
Narara

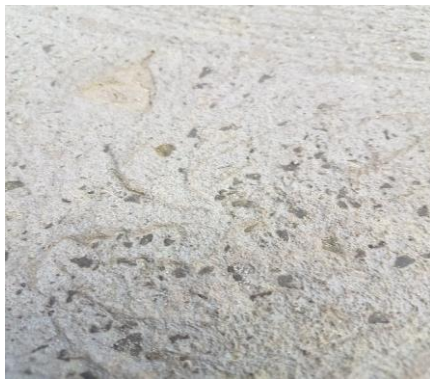
The slabs have crusher dust apparent on the surface, this fine aggregate has not been screeded properly to sink the aggregates, prior to trowel or float work.

This could be a fault in the mix of concrete as there should be at least 10mm or 20mm aggregate, refer to the concrete supplier for more detail on the batch used

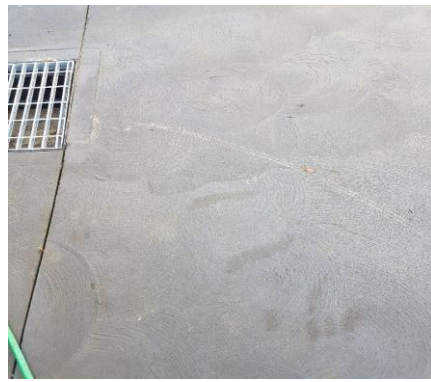
There are great inconsistencies in the shades of colour of the concrete, given the colour was added at the plant, the only reason may be in the time spent trowelling each section, the water or slump varying in each section, or inconsistent trowel work time spent on each section with some parts being worked too wet or too dry

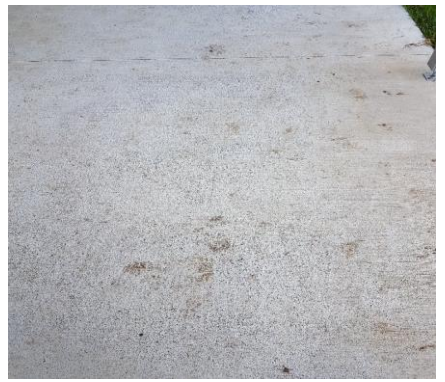
Fine aggregates are noted on the rear patio close to the surface, this appears to be crusher dust and should be no smaller than 10mm aggregate, check the supplier to see if the batch was N20/10 or N20/20, being 20MPA strength and 10 or 20mm aggregate

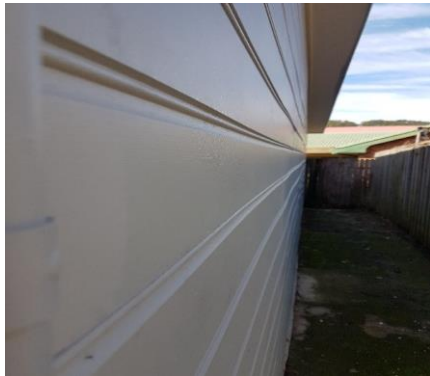
The cladding is very wavy as it follows non-straight timber substrates, the Builder should have taken more care to straighten the studs prior to cladding the garage.

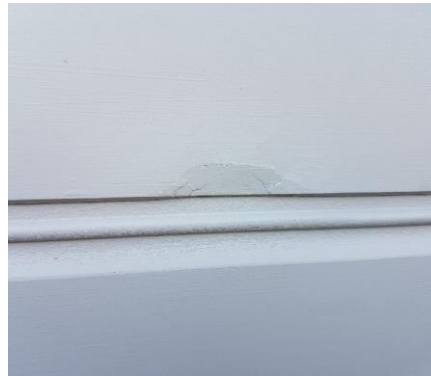
Several cladding timbers have damage caused by shipping and/or slings or forklifts, The builder should have taken more care to cut out these damaged pieces during the cladding process or return the product to the supplier for higher quality materials.

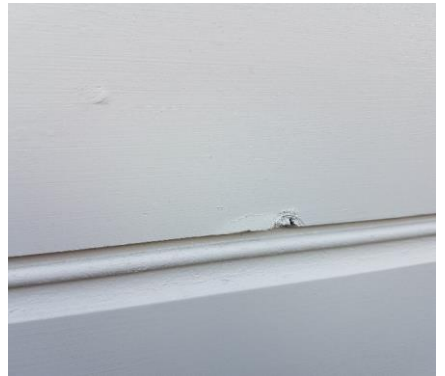
Several cladding timbers have damage caused by shipping and/or slings or forklifts, The builder should have taken more care to cut out these damaged pieces during the cladding process or return the product to the supplier for higher quality materials.

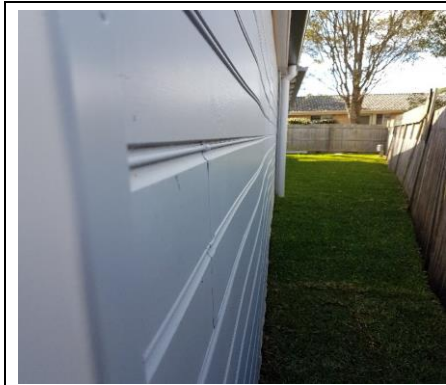
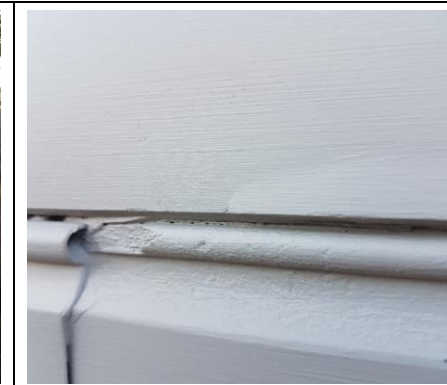
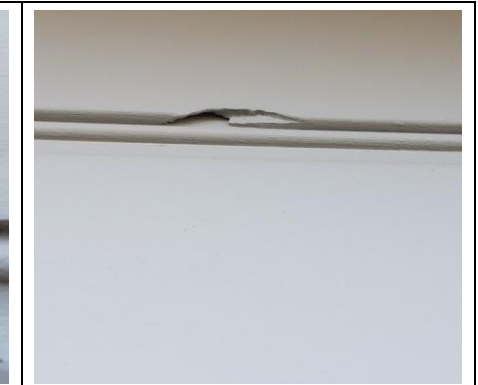
<p>The cladding is very wavy as it follows non-straight timber substrates, the Builder should have taken more care to straighten the studs prior to cladding the garage.</p>	<p>Several cladding timbers have damage caused by shipping and/or slings or forklifts, The builder should have taken more care to cut out these damaged pieces during the cladding process or return the product to the supplier for higher quality materials.</p>	<p>Several cladding timbers have damage caused by shipping and/or slings or forklifts, The builder should have taken more care to cut out these damaged pieces during the cladding process or return the product to the supplier for higher quality materials.</p>

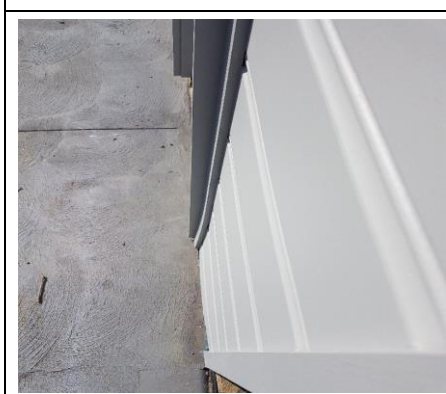
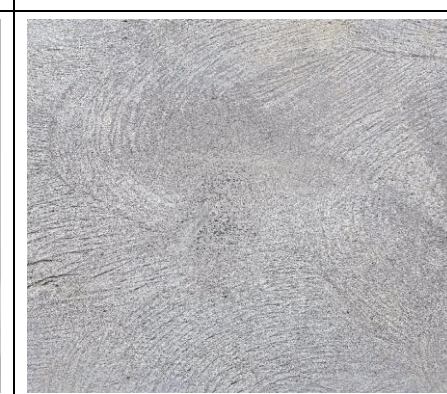
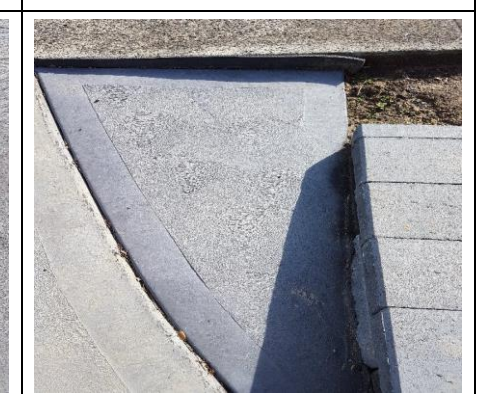
<p>The cladding is very wavy as it follows non-straight timber substrates, the Builder should have taken more care to straighten the studs prior to cladding the garage.</p>	<p>There are great inconsistencies in the shades of colour of the concrete, given the colour was added at the plant, the only reason may be in the time spent trowelling each section, the water or slump varying in each section, or inconsistent trowel work time spent on each section with some parts being worked too wet or too dry</p> <p>Fine aggregates are noted on the rear patio close to the surface, this appears to be crusher dust and should be no smaller than 10mm aggregate, check the supplier to see if the batch was N20/10 or N20/20, being 20MPA strength and 10 or 20mm aggregate</p>	<p>This small piece near the foot path is pretty much exactly how the whole driveway should look, consistent in colour, consistence cove trowel work, and no fine aggregate material near the surface.</p> <p>Unfortunately, there is a trip hazard created where the new meets the old footpath. This should have been shaped up to prevent the trip hazard.</p>

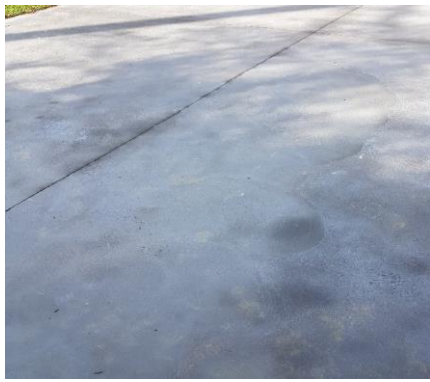
There are great inconsistencies in the shades of colour of the concrete, given the colour was added at the plant, the only reason may be in the time spent trowelling each section, the water or slump varying in each section, or inconsistent trowel work time spent on each section with some parts being worked too wet or too dry

Fine aggregates are noted on the rear patio close to the surface, this appears to be crusher dust and should be no smaller than 10mm aggregate, check the supplier to see if the batch was N20/10 or N20/20, being 20MPA strength and 10 or 20mm aggregate

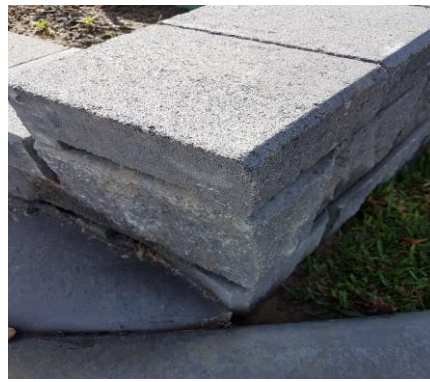
The method of laying the retaining wall blocks is not consistent with a wall laid in a proper workmanship type manner, the use of Sikaflex to hold the cap tiles on is rather rudimentary and a mortar slurry should have been used, the edges of the cap blocks have not been mitered off leaving the wall unpleasant.

A stone mason or bricklayer with block wall experience should be engaged to properly lay the retaining walls.

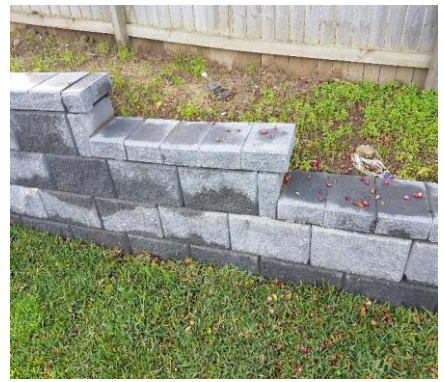
The method of laying the retaining wall blocks is not consistent with a wall laid in a proper workmanship type manner, the use of Sikaflex to hold the cap tiles on is rather rudimentary and a mortar slurry should have been used, the edges of the cap blocks have not been mitered off leaving the wall unpleasant.

A stone mason or bricklayer with block wall experience should be engaged to properly lay the retaining walls.

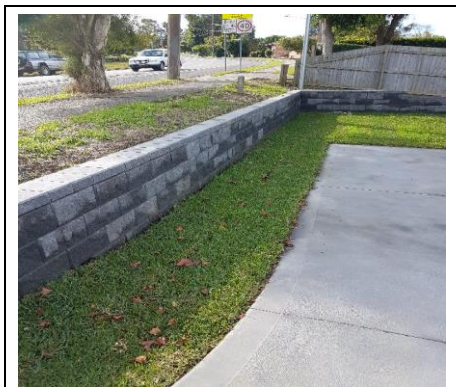
The retaining walls are over 600mm in height and should have engineered plans as required by Council.

They are not core filled with concrete or steeled up with metal reinforcement rods during the construction. As such this will fail to retain the earth in a short space of time. Recommend an engineer fully report on the retaining walls adequacy.
