Pro Property Reports

PRE-PURCHASE STANDARD TIMBER PEST REPORT

Report number: 1606172
Inspection date: 16 Jun 2017
Property address

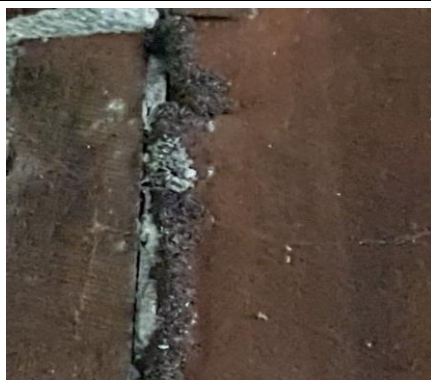
Visible evidence of subterranean termite workings and/or damage was found at the time of inspection. It was in, but not necessarily limited to the following location(s)the garage.

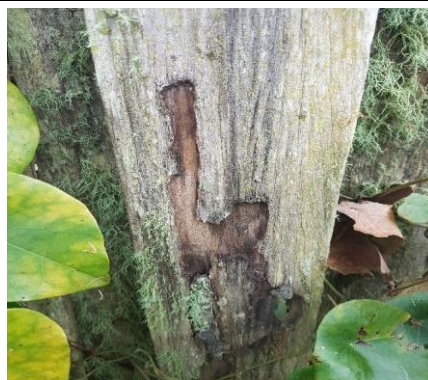
Termite damage and workings to Fences was detected, notably those in direct contact with the ground and also in some cross-rails and posts.

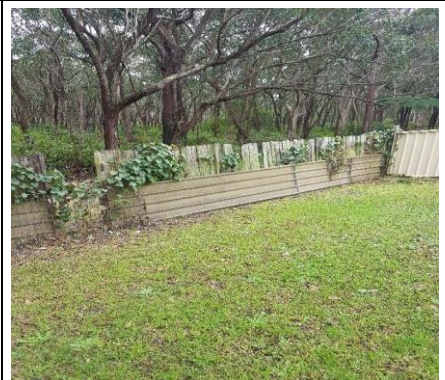
Termite damage and workings to Fences was detected, notably those in direct contact with the ground and also in some cross-rails and posts.

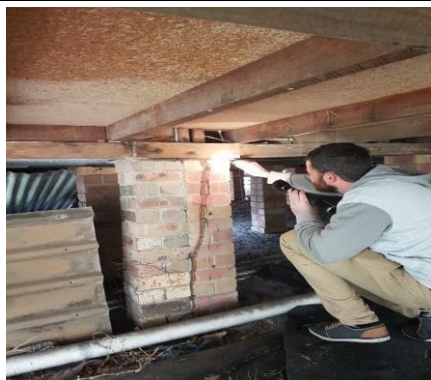
Visible evidence of subterranean termite workings and/or damage was found at the time of inspection. It was in, but not necessarily limited to the following location(s)piers and subfloor up to the ceiling.

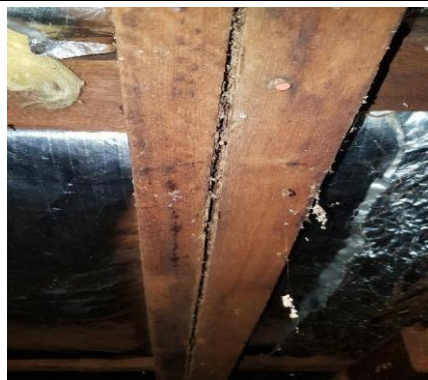
Workings in the roof space with no structural damage noted in the accessible areas checked.

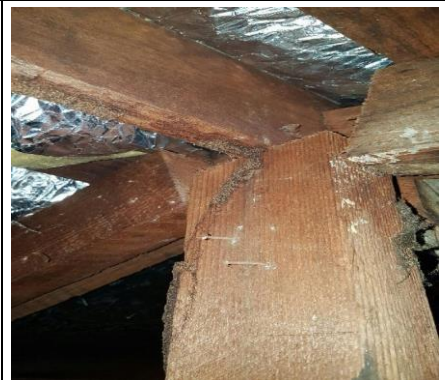
Workings in the roof space with no structural damage noted in the accessible areas checked.

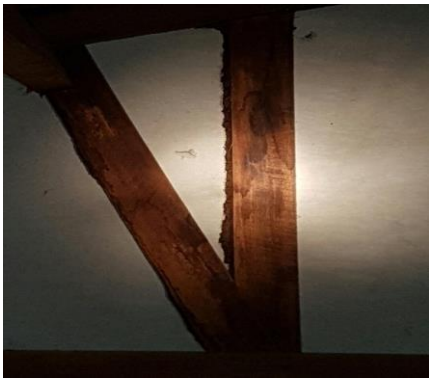
Workings in the roof space with no structural damage noted in the accessible areas checked.

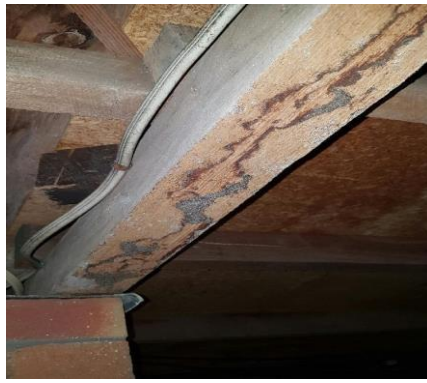
Workings in the subfloor with no structural damage.

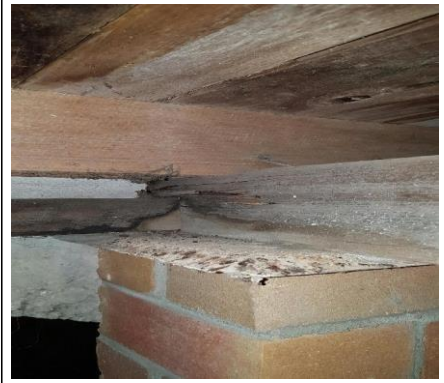
Visible evidence of subterranean termite workings and/or damage was found at the time of inspection. It was in, but not necessarily limited to the following location(s) subfloor bearers have damage and have weakened due to the floor loads. Recommend builder repair or support the bearers where damage occurred.

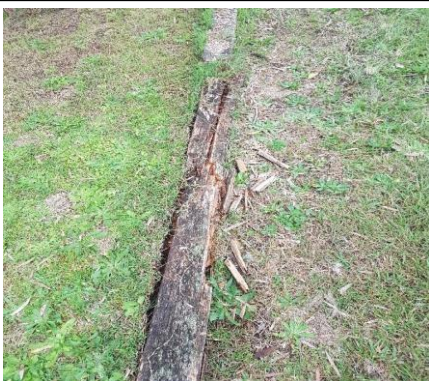
Timbers in contact with the ground, these are susceptible to termite activity. We would recommend replacing with less susceptible materials, ie masonry, steel or cca treated pine.
