Pro Property Reports

STANDARD HANDOVER/ CONDITION REPORT

Report number: 212161

Inspection date: 08 Dec 2016

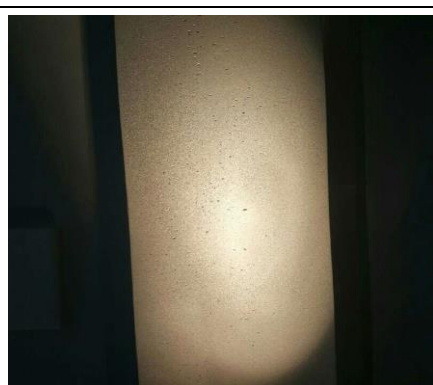
Front entry plaster square setting opening is full of air bubbles and requires filling and painting.

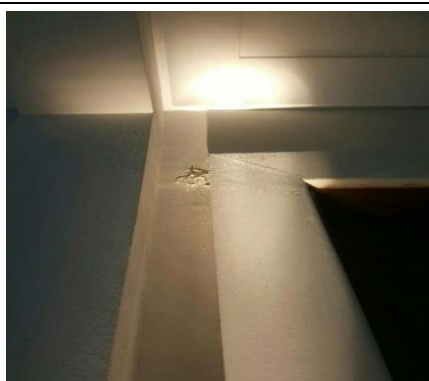
Front entry plaster internal square setting is rough and requires resetting and painting.

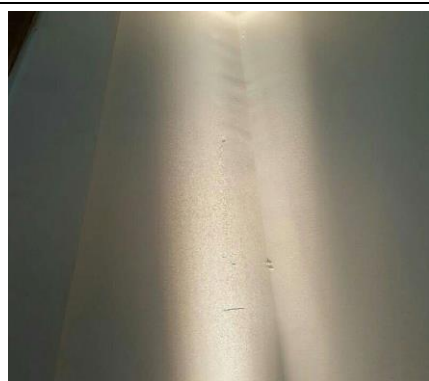
Front entry plaster internal square setting is rough and requires resetting and painting both sides of the front door.

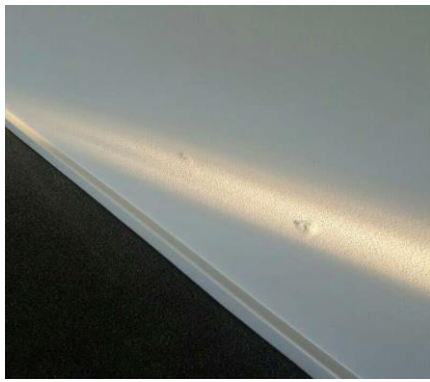
Front lounge room plaster damage. Needs further sanding and painting.

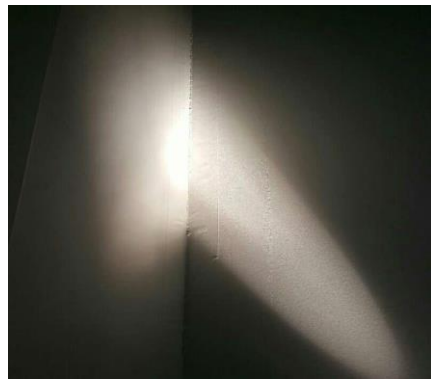
Internal corner of linen cupboard requires re square setting internal corner and repainting

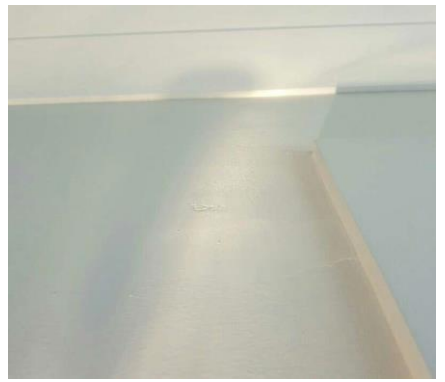
Main bedroom window plaster damage. Needs further sanding and painting.

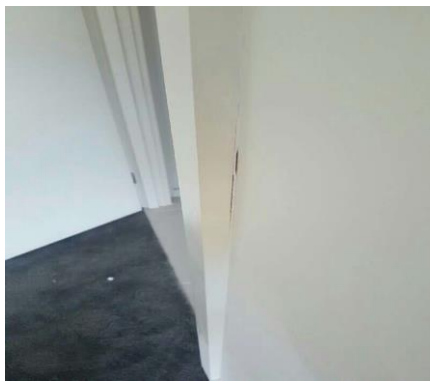
Main bedroom door jambs are gappy and need no gapps to seal cracks.

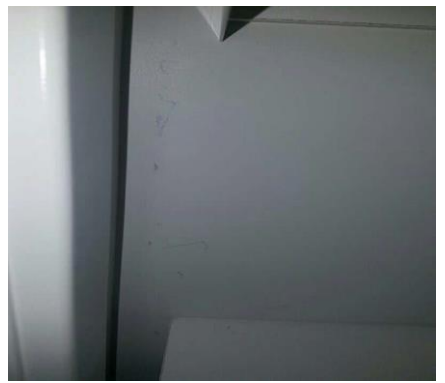
Scrub marks inside linen cupboard plaster damage. Needs further sanding and painting.

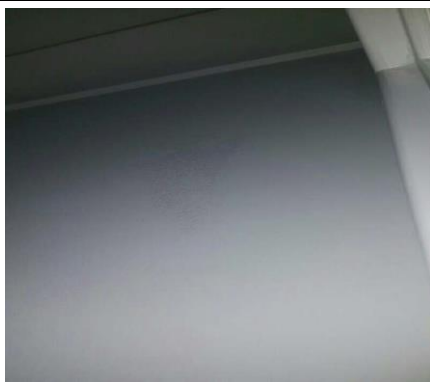
Bedroom 2 inside cupboard plaster damage. Needs further sanding and painting.

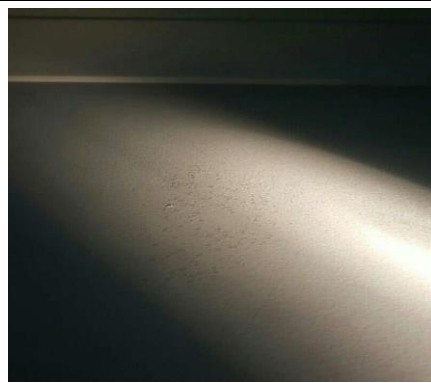
Small hall way plaster / PAINT damage. Needs further sanding and painting.

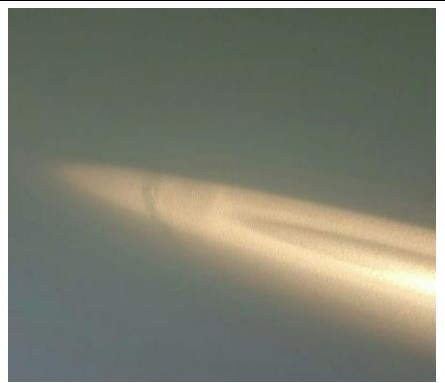
Kitchen dining room plaster damage. Needs further sanding and painting.

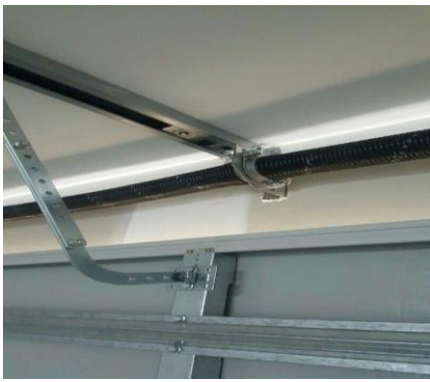
Garage door heads require painting.

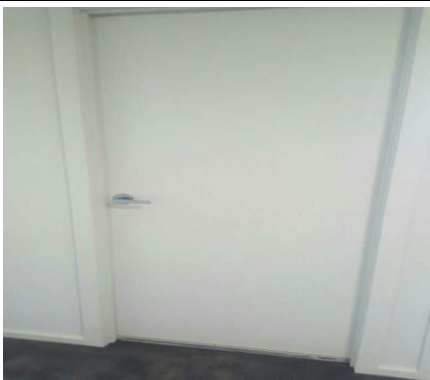
Laundry door binds at the bottom.

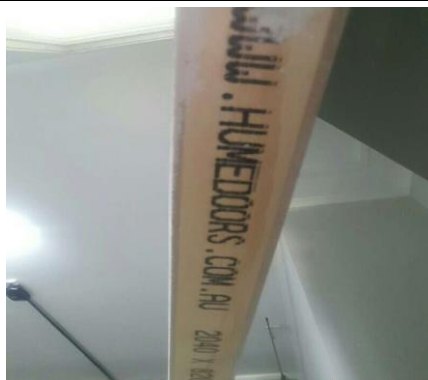
Mostly all the internal doors that were visible are unpainted on the bottom mullion. This is required to seal the door and stop swelling during high humidity conditions.

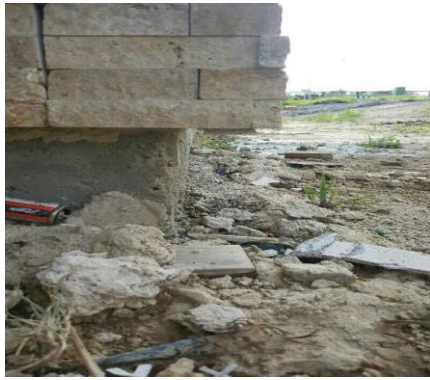
Brickwork across the front of the home front bedroom is overhanging the slab and exceeds the BCA codes for overhang. Maximum is approx 25mm. The worst area is about 75mm overhang.

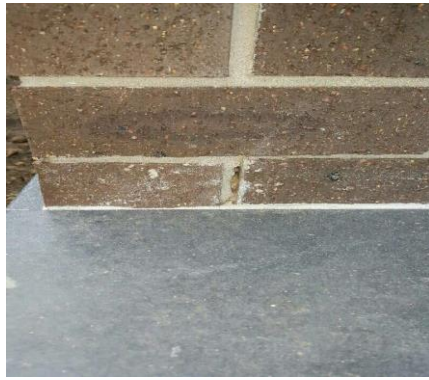
Blocked weep holes with mortar in many locations around the perimeter noted. These need cleaning out.

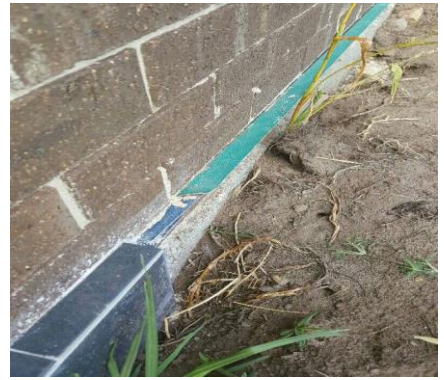
Kordon or Trithor needs trimming back flush with the brickwork.

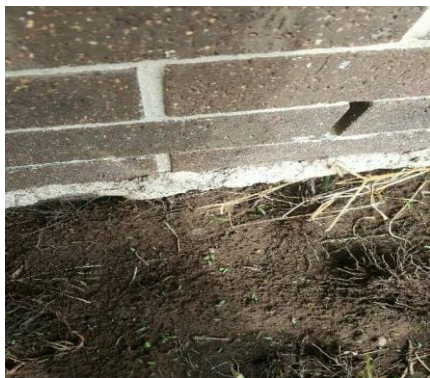
Excess mortar at the slab level needs trimming off flush with the brickwork.

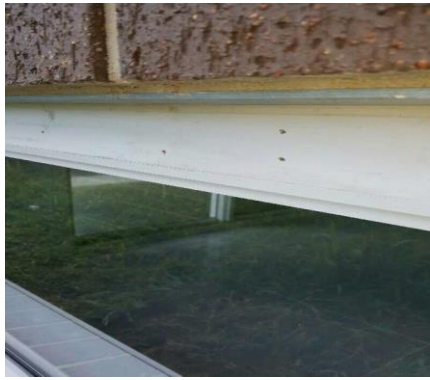
Unpainted timber reveals on rear window on the dining room.

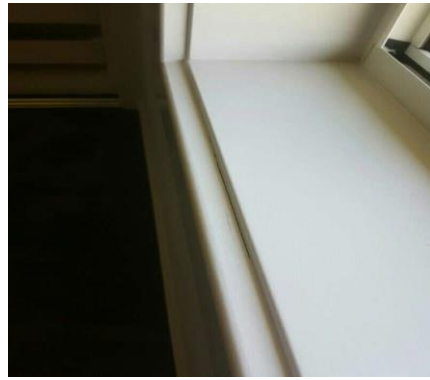
Gap filling of bedroom 3 window architraves required.

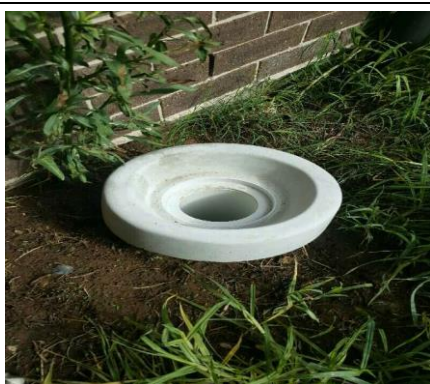
Gully needs cover fitted.
